# Manhole Inspection Summary

Manhole # S29U\_\_009MH

Insp Date: **10/29/08 3:48 PM**

**Location** Address: **1645 Warner St.**

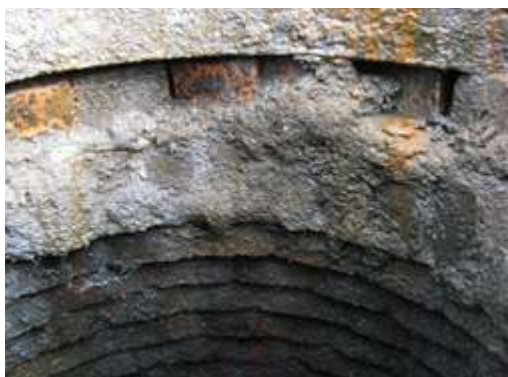
Miscellaneous

signs of lid/frame infiltration and sand buildup

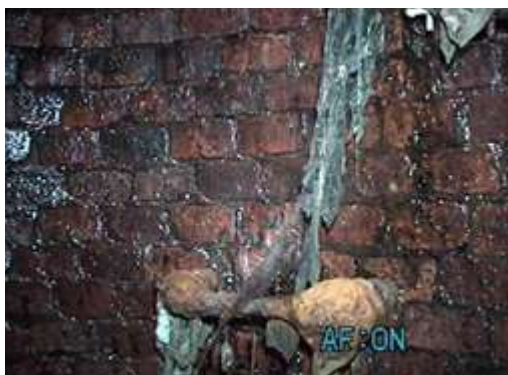
Defect 7

☒ **Evidence Of Surcharge** Depth: **4** (ft.) ☐ Active Surcharge Present

Surcharge evidence

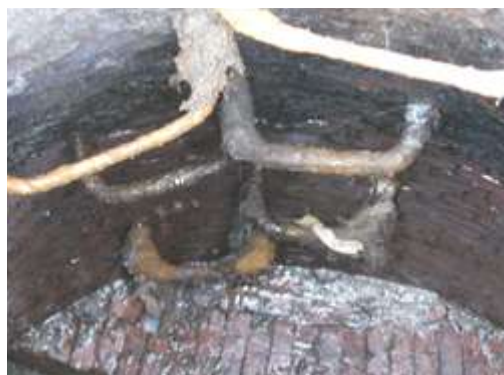
Defect 4

Count: **6** Missing: **0** ☒ **Corroded**

corroded rungs

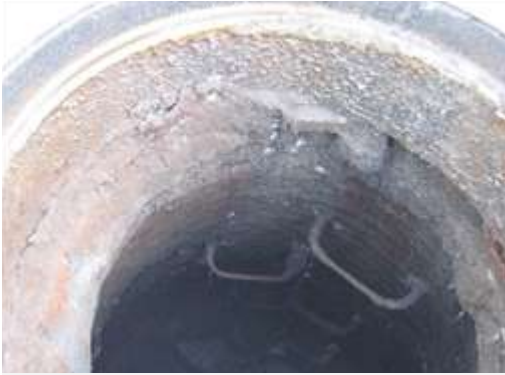
Defect 6

Condition: ☐ Sound ☐ Cracked ☐ Root Intrusion ☒ **Loose Brick** ☒ **Deteriorated**

Condition: ☐ Sound ☐ Cracked ☐ Root Intrusion ☐ Loose Brick ☒ **Deteriorated**

corbel, chimney\_deteriorated

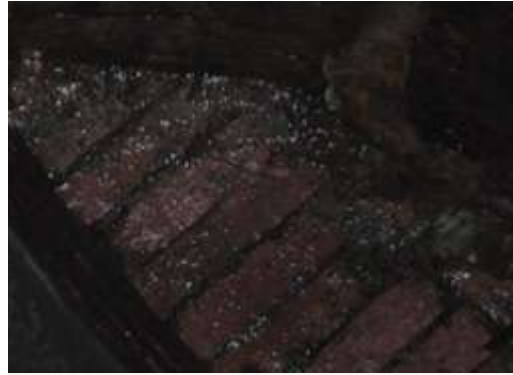
Defect 3

Infiltration: ☐ None ☐ Joint ☐ Cracks ☐ Mortar ☐ Roots ☒ **Wall**

barrel infiltration

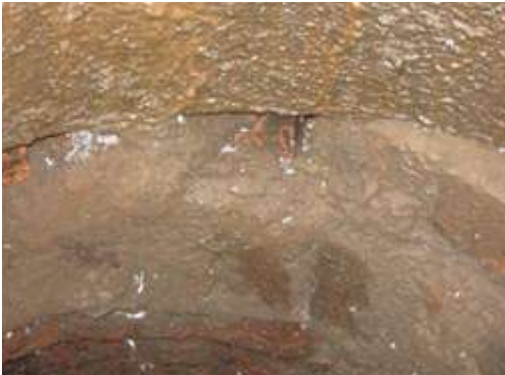
Defect 2

Infiltration: ☐ None ☐ Joint ☐ Cracks ☐ Mortar ☐ Roots ☒ **Wall**

missing brick with chimney infiltration

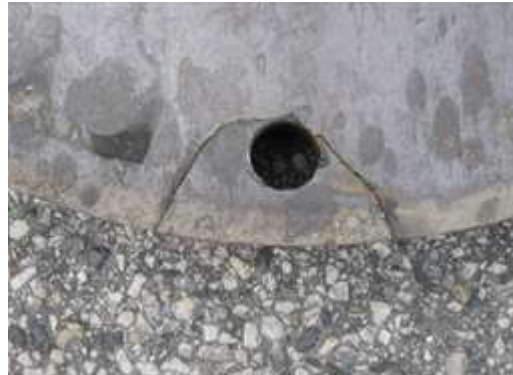
Defect 1

Condition: **Cracked**

cracked lid

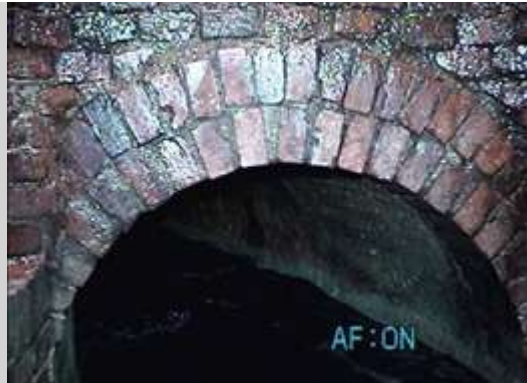
6 O'Clock Inflow

infiltration
